Tree Inventory, Assessment, and Protection Report

451 Santa Rosa Drive, Los Gatos Los Gatos, CA 95032

Town of Los Gatos

October 18, 2021

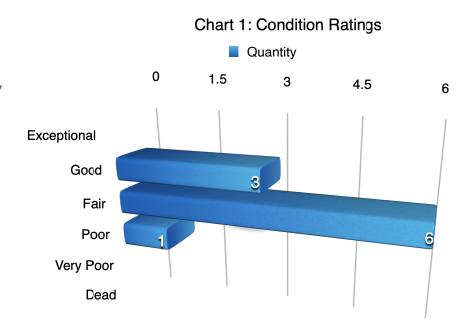
One tree is in poor shape which is the severely leaning coast live oak #740 (Chart 1). Three trees are in good condition including the unique specimen #745 and two other Large Protected #744 and #751. The remaining six trees are all in fair shape with some structural defects or conditions not optimal for the trees

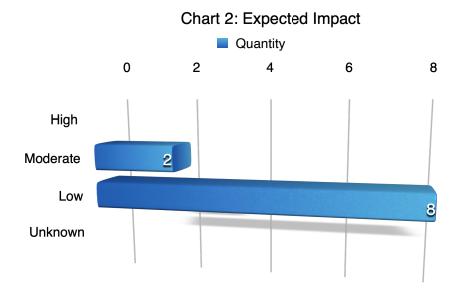
No trees are expected to be highly impacted or removed (Chart 2). There are two trees that would likely be moderately impacted which are #743 and #744. The impacts largely would come from the ingress and egress to the site work area. There is an access road to the lower yard where the pool would be constructed. However to get to the work area the only access is between the two trees. Along with exclusion with fence using mulch or timers to bridge the root area between the trees with three quarter inch plywood or steel road plate is to be employed. The L1.6 Plan actually already calls out this protection measure.

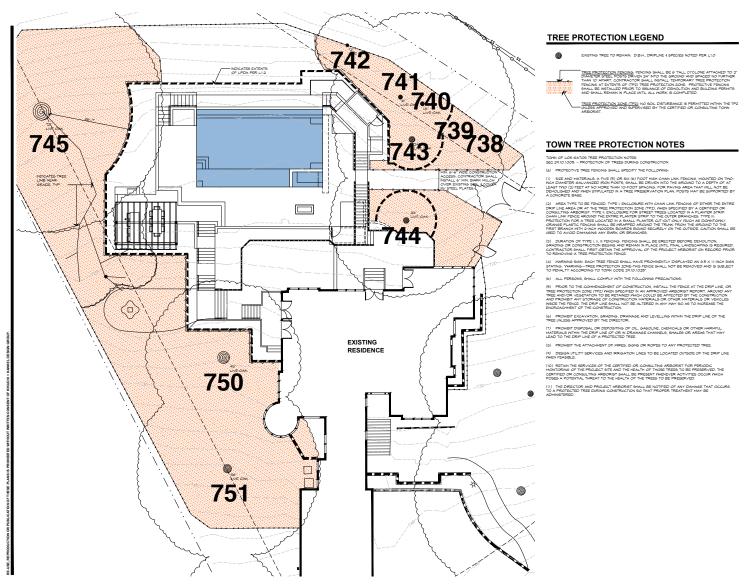
A3: L1.6 Tree Protection Plan

Tree protection has been provided in the L1.6 plan sheet. There is a combination of fence to provide exclusion from root zones and bridging with mulch and steel road plate at the ingress/egress between tree #743 and #744 (Figure 1). I provided recommended offsets for fence distances where possible in Appendix B. The L1.6 plan should also include this report along with the "Recommendations" section and Appendix B, D and E. Based on the site constraints and already impacted areas the L1.6 plan is adequate for fence locations and bridging measures.

- 6. Place all the tree protection fence locations and guidelines on the plans including the grading, drainage, and utility plans. Create a separate plan sheet that includes all three protection measures labeled "T-1 Tree Protection Plan."

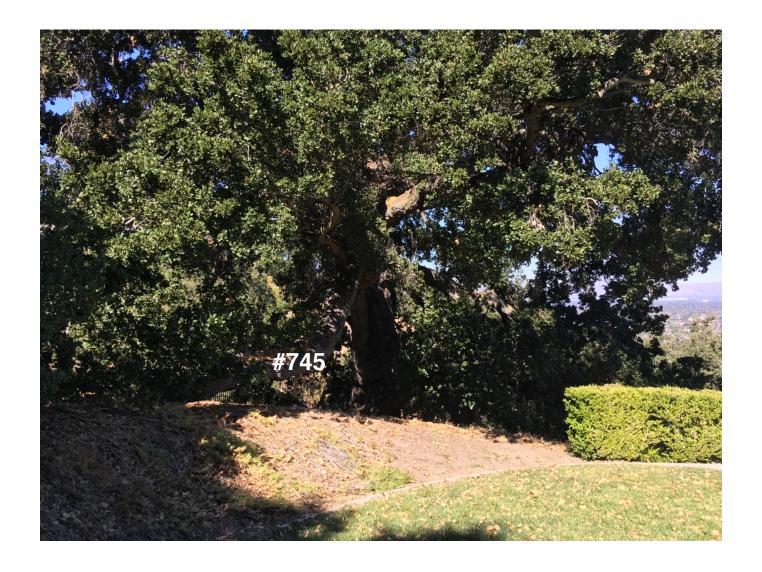
C3: Tree #745

^{*} Tree #745 is an unusually large specimen in good condition. I cannot remember seeing another like it in recent years in Los Gatos. Care should be taken in maintaining and inspecting this tree, which has several large limbs extending to the ground and back up again.
